AD NUMBER	
AD357977	
CLASSIFICATION CHANGES	
TO:	UNCLASSIFIED
FROM:	SECRET
LIMITATION CHANGES	
TO: Approved for public release; distribution is unlimited. Document partially illegible.	
FROM: Distribution authorized to U.S. Gov't. agencies only; Administrative/Operational Use; 1953. Other requests shall be referred to Atomic Energy Commission, Washington, DC. Document partially illegible.	
AUTHORITY	
AEC ltr 16 Jun 1980 ; AEC ltr 16 Jun 1980

The purpose of Signal Corps participation in Project 3.20 was to determine the amounts of thermal flux (cal) and peak overpressure (psi) required to cause severe, moderate, light, and negligible damage to selected signal communications-electronics items of equipment and material for which inadequate or no data existed. Knowing these factors it is believed that responsible signal officers can better plan their tactical communications systems and take passive protective measures to reduce damage and losses to acceptable minimums. These data will also be used to improve design of equipment and material.

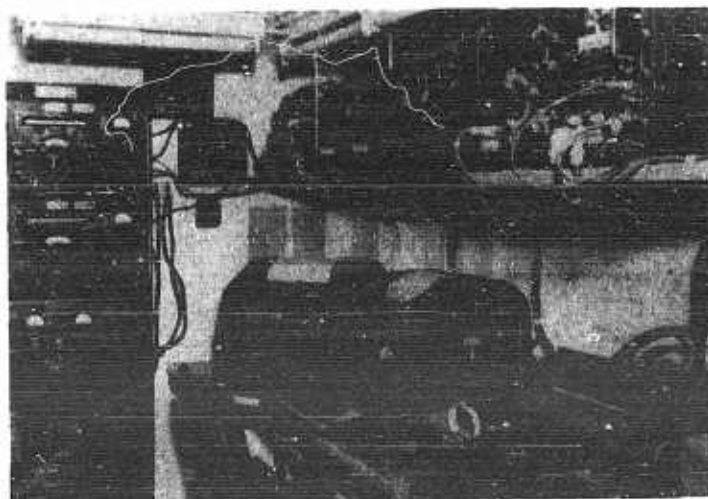
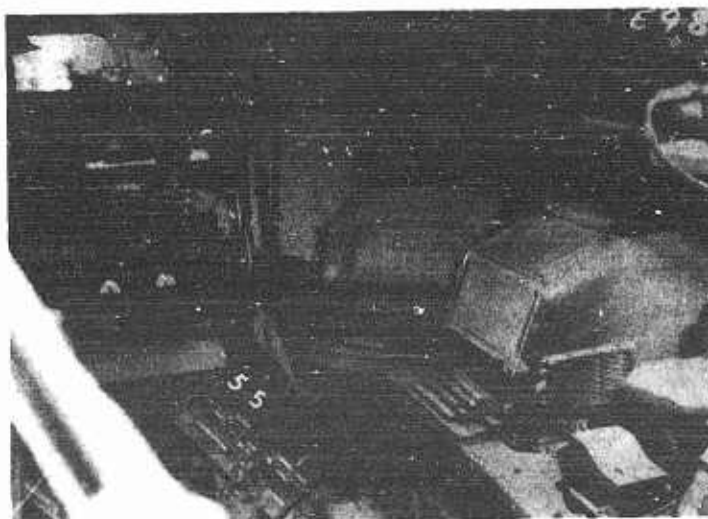
Fig. 3.113 Shot 9, Test Group 55, AN/GRC-26 Radio Set Details. (Top, Interior View before Blast, Bottom, Interior View after Blast.) Radio Receiver Taken out before Picture Taken. 1700 ft, 91 cal, 13.8 psi, 3600 r at Surface, 572 r in Shelter.

Test Group No.	Ft from GZ	cal	psi	Surface Gamma	Interior Gamma	D A M A G E			Remarks
						Thermal	Blast	Gamma	
AN/GRC-26 Radio Sets									
55	1700	91	13.8	3600	572	L	S	S	Paint burned on exposed parts of S-56 shelter. Some sandbags burned spilling sand. Front of S-56 shelter blown in. Debris and blast caused severe to no damage to equipment. Set not operative without major repairs. Whip antennas bent. PE-95 power unit received light damage and was operative after light repairs made. Gamma alone could cause 100% deaths to operating personnel.
81	2425	58.5	10.6	2280	Film Badges Burned	S	S	S	This radio set completely gutted by fire, whip antennas bent and blown off. Gamma alone could cause 100% deaths to operating personnel.
56	3500	49	9.4	840	316-168	L	S	S	Paint scorched on exposed parts of Shelter. Some sandbags burned, spilling sand. Front of S-56 shelter blown in. Debris and blast caused severe to no damage to equipment. Set not operating without major repairs. Whip antennas bent and one broken off at top.

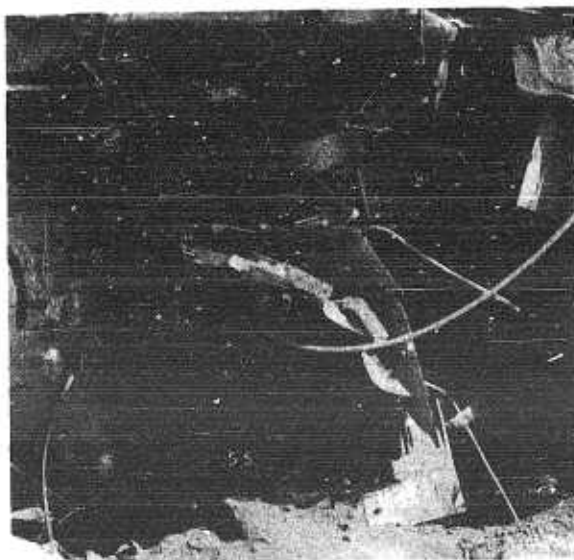
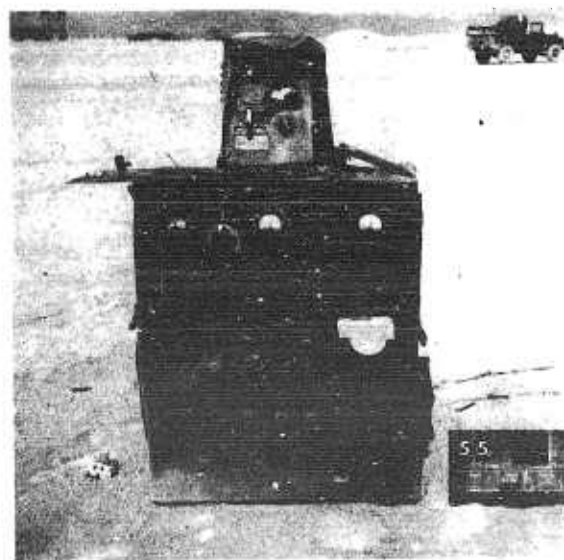
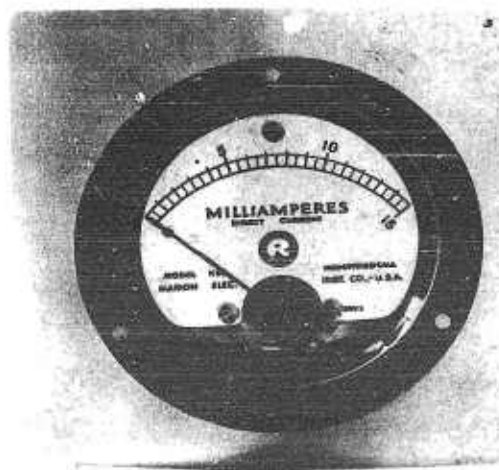
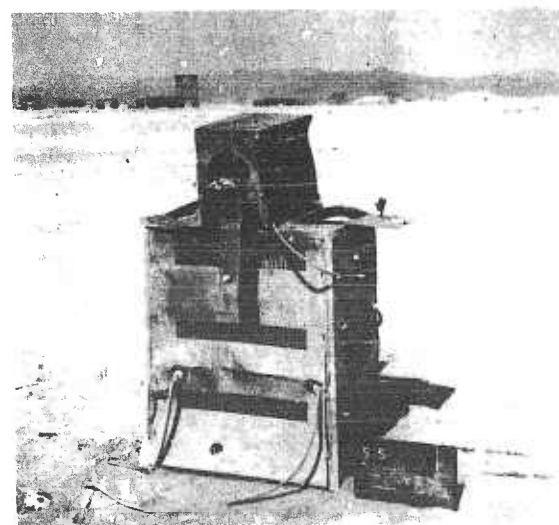
Ruggedized Meter in AN/GRC-26 Transmitter

Fig. 3.113A Shot 9, Test Group 55, AN/GRC-26 Radio Set Detail Photos - All Photos after Shot. Top left, interior of S-56 Shelter; Bottom left, ruggedized Milliammeter in BC-610 Transmitter; Top right, BC-610 Transmitter after Removal from S-56 Shelter, Front View. 1700 ft, 91 cal, 13.8 psi.

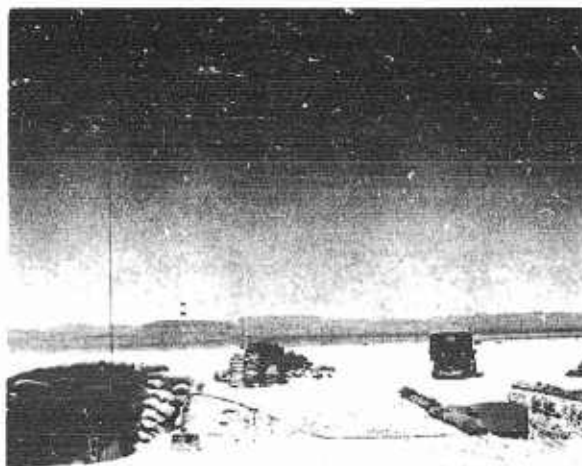
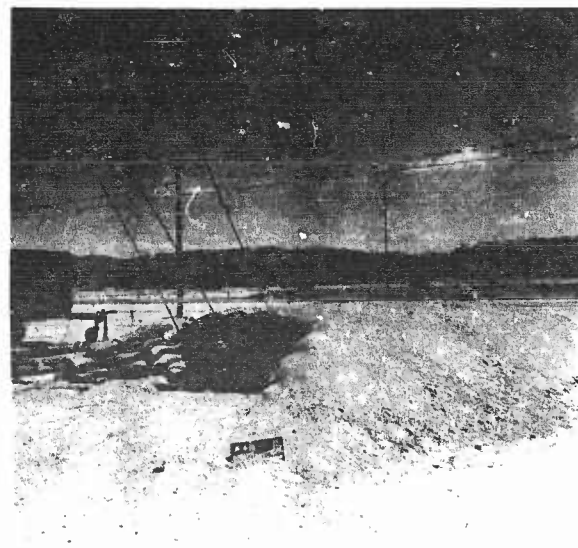
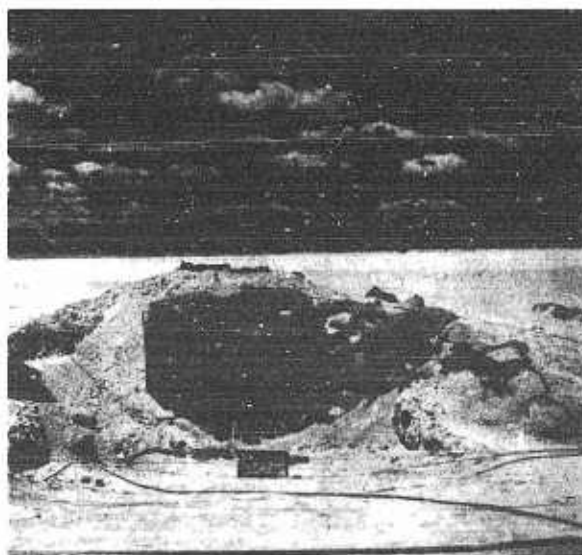
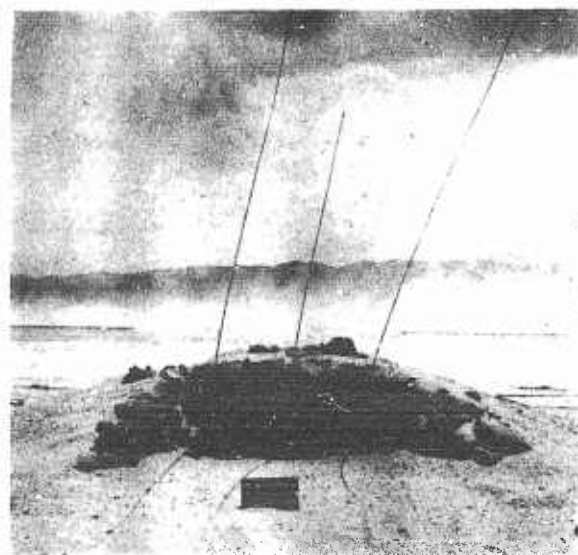
Fig. 3.114 Shot 9, Test Group 56, AN/GRC-26 Radio Set (Revetted).
 (Top left-before, Bottom left-after, Top right, Rear
 View-before, Bottom right, Rear View-after.) 3500 ft,
 49 cal, 9.4 psi, 840 r at Surface, 316-168 r in S-56
 Shelter.

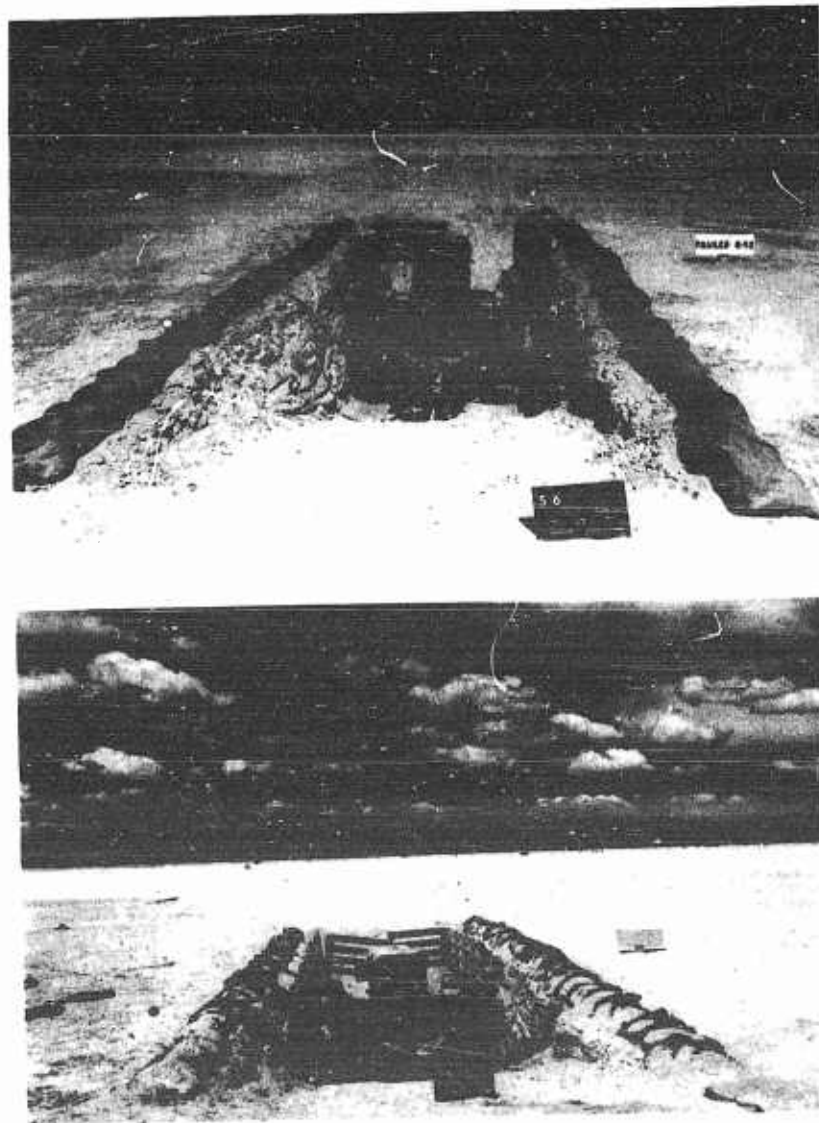
Fig. 3.115 Shot 9, Test Group 56, PE-95 Power Unit, Part of AN/GRC-26 Radio Set (In Open Ended Pit). (Top-before, Bottom-after) 3500 ft, 49 cal, 9.4 psi.

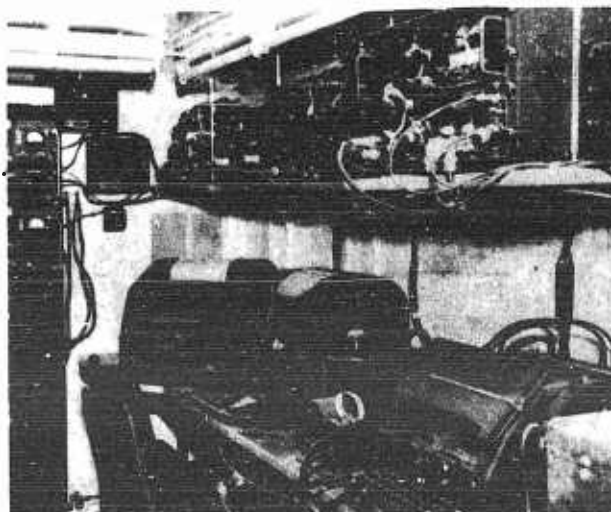
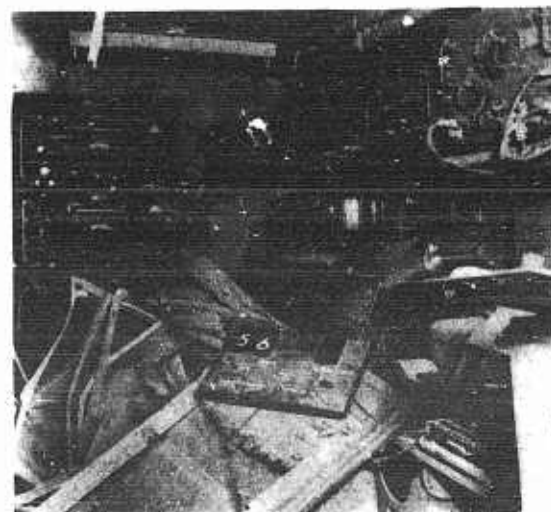
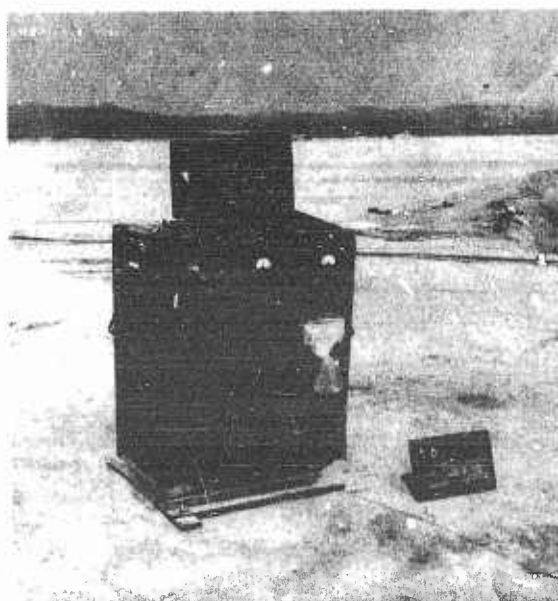
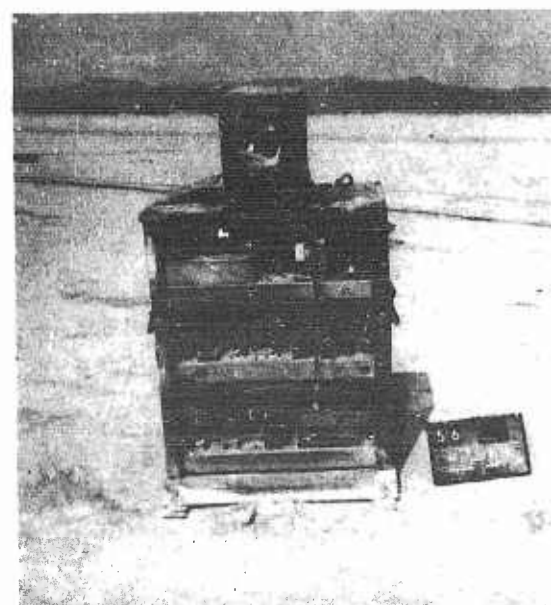
Fig. 3.116 Shot 9, Test Group 56, AN/GRC-26 Radio Set Detail Photos (After).
Top left, interior of S-56 Shelter before blast; lower left, BC-610 Transmitter, front view; bottom right, BC-610 Transmitter, rear view, panel removed; top right, shelter interior after blast. 3500 ft, 49 cal, 9.4 psi, 840 r at surface, 316-168 r in shelter.

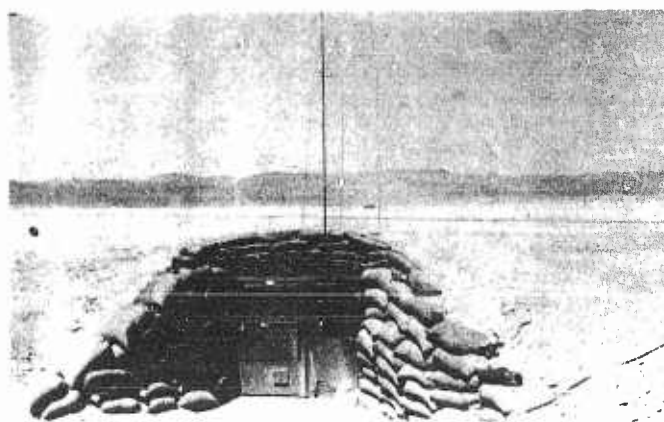
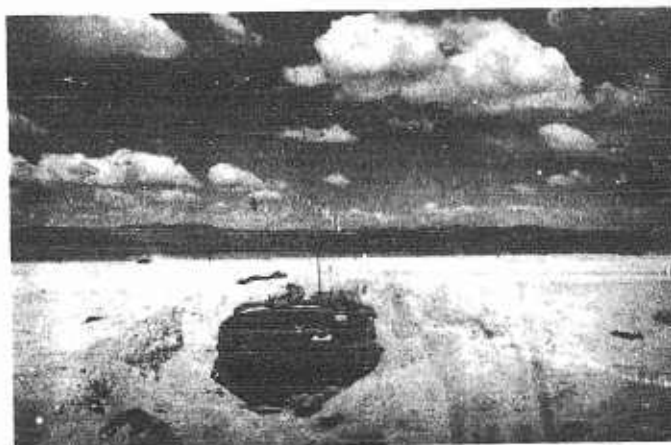
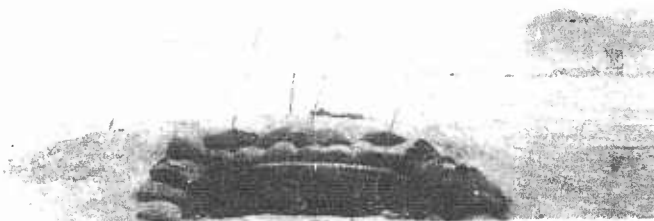
Fig. 3.117 Shot 9, Test Group 57, AN/GRC-26 Radio Set.
 (Top-before, Center-after, Bottom, Rear View-
 after) 4500 ft, 34 cal, 7 psi, 200 r at
 Surface, 96 r in S-56 Shelter.

Test Group No.	Ft from GZ	cal	psi	Surface Gamma	Interior Gamma	D A M A G E			Remarks
						Thermal	Blast	Gamma	
57	4500	34	7	200	96	L	S	L	PE-95 power unit received light blast damage and was operative after minor repairs made. Gamma alone could cause over 20% deaths and incapacitate all for over three months.
58	5550	25	5.6	80	44	N	S	L	Paint scorched on exposed parts of S-56 shelter. Some sandbags burned, spilling sand. Front of S-56 shelter blown in. Debris and blast caused severe to no damage to equipment. Set not operative without major repairs. PE-95 Power Unit received light blast damage and was operative after minor repairs made. Gamma alone would not cause deaths or incapacitate operating personnel.
									Light scorching of paint. Some sandbags burned, spilling sand. Front of S-56 shelter blown in. Debris and blast caused moderate to no damage to equipment. Set not operative without major repairs. (This set had no PE-95 Power Unit in the test.) Gamma alone would not cause deaths or incapacitate operating personnel.

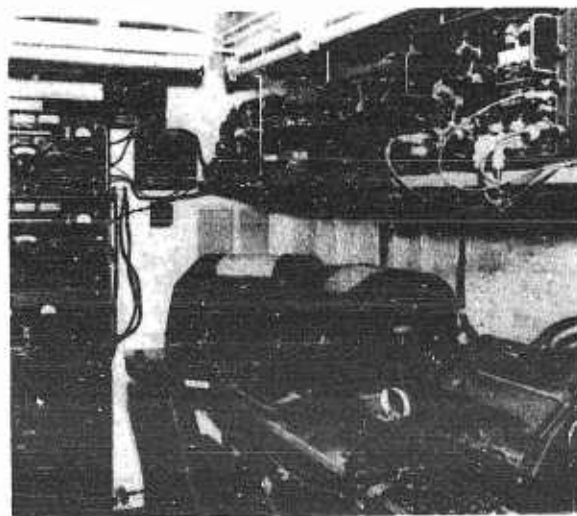
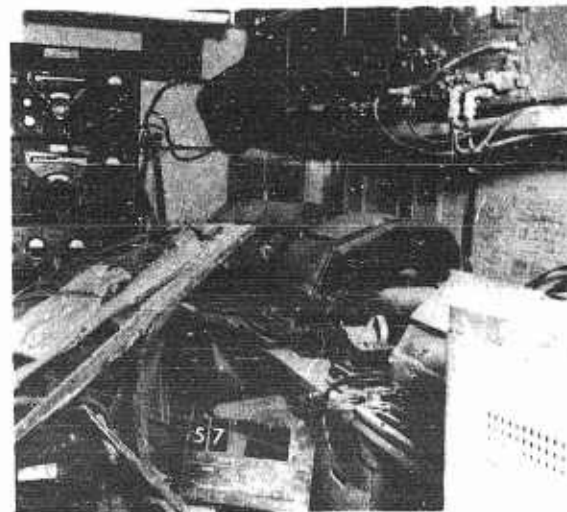
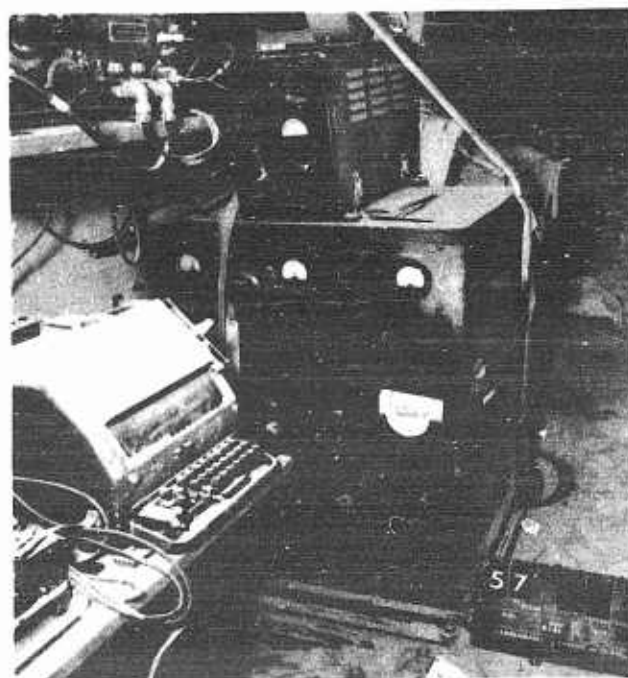
Fig. 3.117A Shot 9, Test Group 57, AN/GRC-26 Details.
(Top left-interior View before Blast, Top
right and Bottom, Interior View after Blast)
4500 ft, 34 cal, 7 psi, 200 r at Surface,
96 r in Shelter.

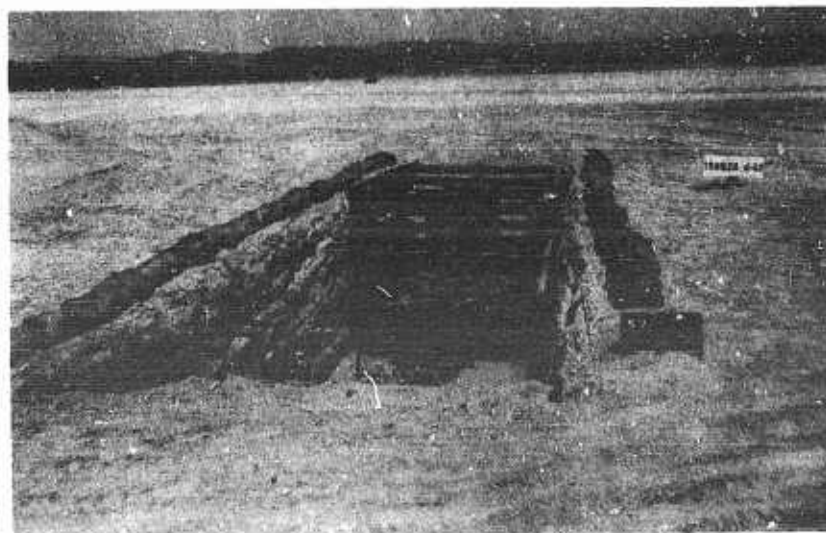
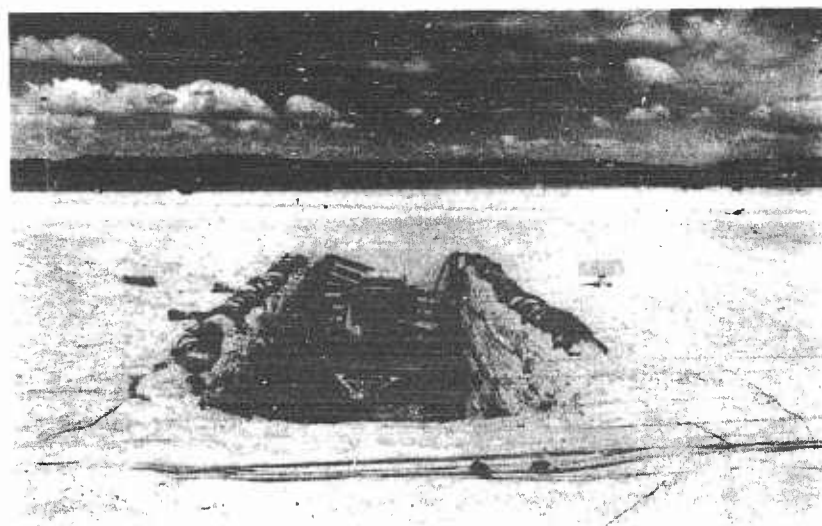
Fig. 3.118 Shot 9, Test Group 57, PE-95 Power Unit in S-56 Shelter. (Top-before, Bottom-after) 4500 ft, 34 cal, 7 psi, 200 r at Surface, 96 r in S-56 Shelter.

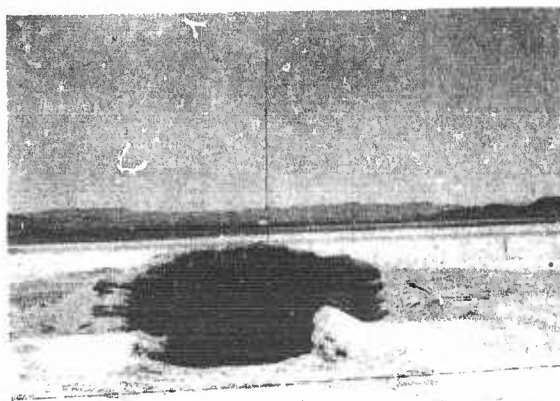
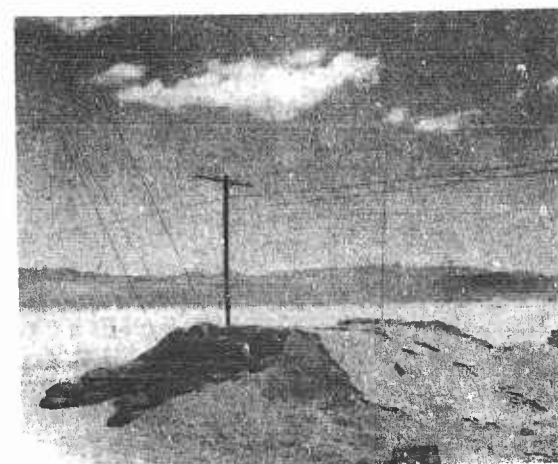
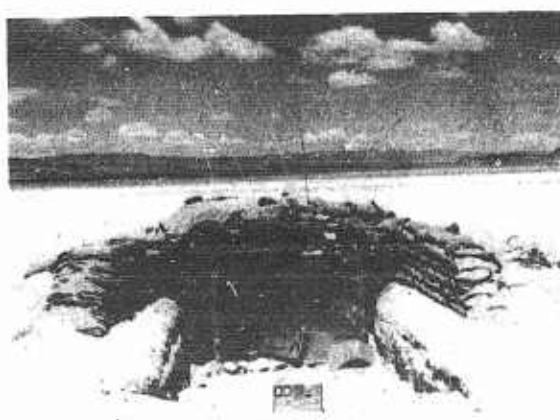
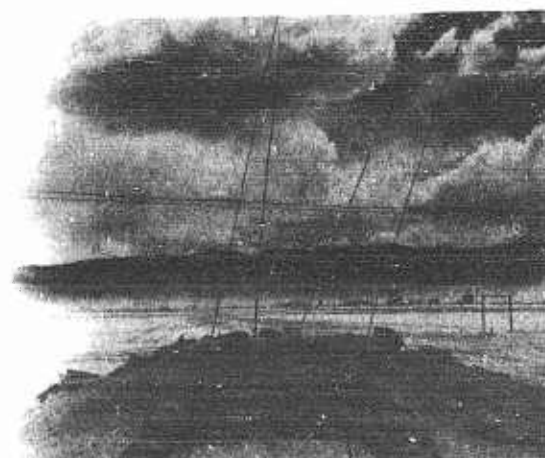
Fig. 3.119 Shot 9, Test Group 58, AN/GRC-26 Radio Set. (Top left-before, Bottom left-after; Top right, rear view-before, Bottom right, rear view-after) 5500 ft, 25 cal, 5.6 psi, 80 r at Surface, 44 r in S-56 Shelter.

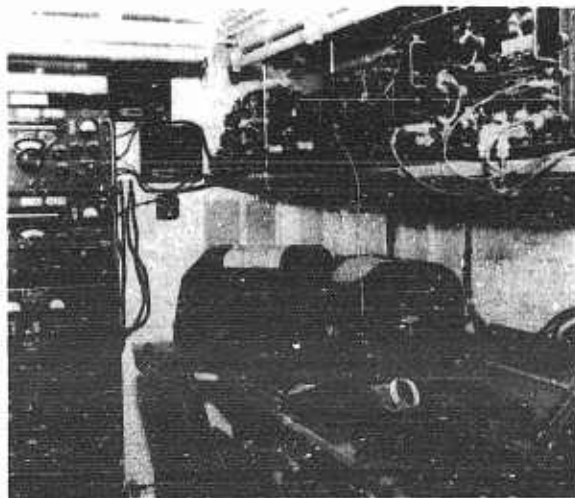
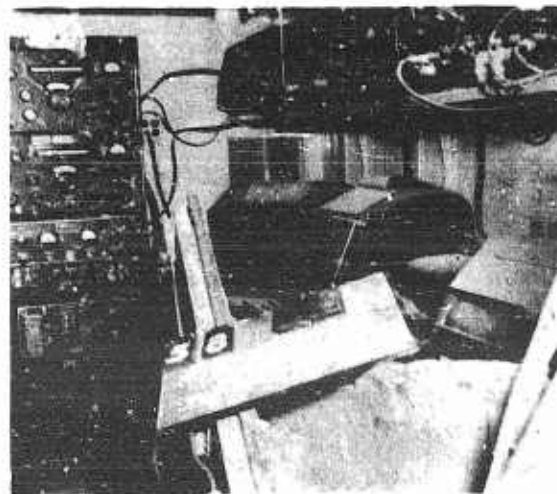
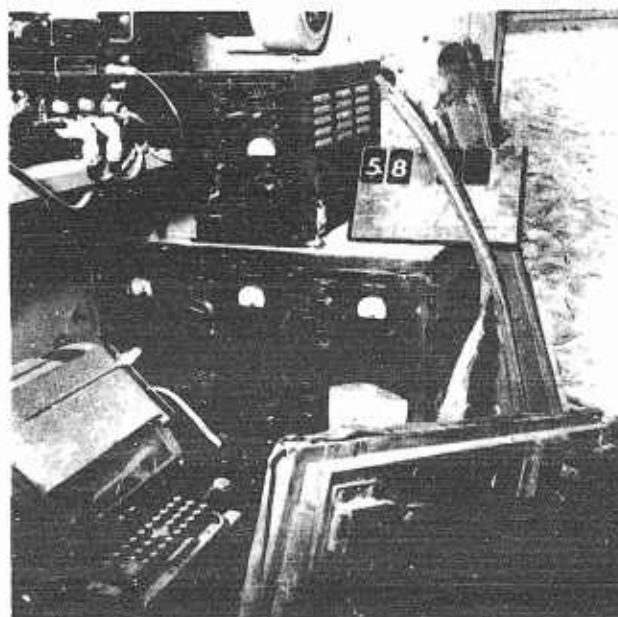
Fig. 3.120 Shot 9, Test Group 58, AN/GRC-26 Radio Set, Detail Photos. (Top left, Interior View before Blast; Top right and Bottom, Interior Views of S-56 Shelter after Blast.) 5000 ft, 25 cal, 5.6 psi, 80 r at Surface, 44 r in S-56 Shelter.

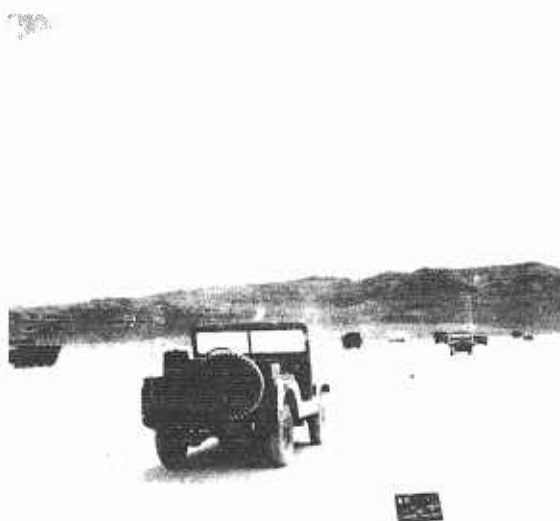
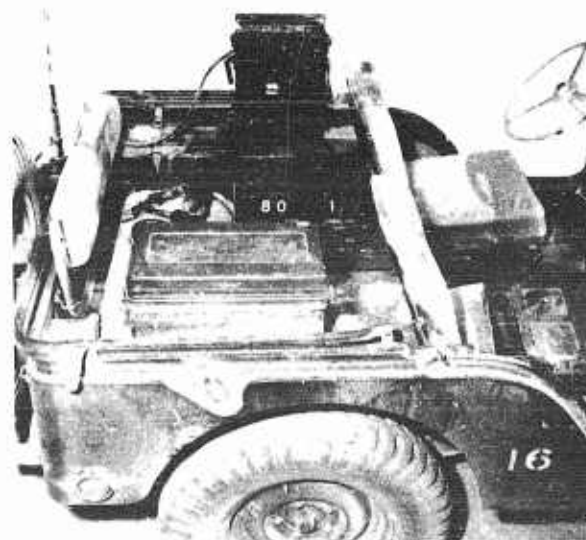
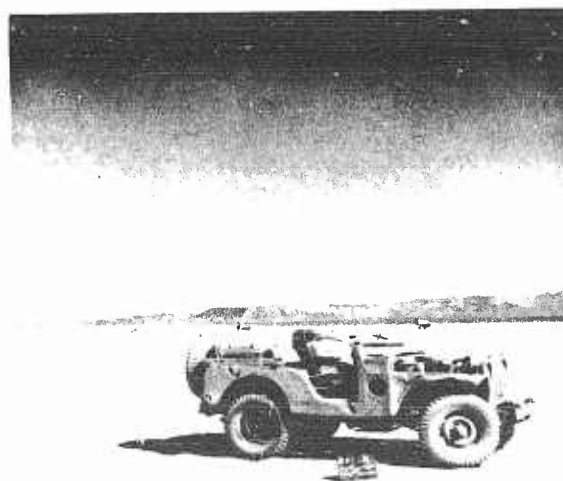
Fig. 3.121 Shot 9, Test Group 80, AN/GRC-9 Radio Set in Ordnance Corps Jeep. (Top left-before, Bottom left-after; Top right-before, Bottom right-after) 1650 ft, 94.5 cal, 14 psi, 368 r at Surface.

Test Group No.	Ft from GZ	cal	psi	Surface Gamma	Interior Gamma	D A M A G E			Remarks
						Thermal	Blast	Gamma	
AN/GRC-9 Radio Sets									
80*	1650	94.5	14	3680	Not applicable	L	L	S	Chassis scorched, calibration charts burned. Antenna bent, some external connections broken. Case of PE-237 power pack dented and top loose. Set operative after minor repairs made. Gamma alone would cause 100% deaths to operating personnel.
81*	2425	58.5	10.6	2280	Not applicable	N	L	S	No thermal damage. Antenna bent and some external connections broken. Set operative after minor repairs. Gamma radiation alone would have caused 100% deaths to operating personnel.
82*	4550	33.5	6.9	200	Not applicable	N	L	M	No thermal damage. Antenna bent and some external connections broken. Set operative after minor repairs. Gamma alone not expected to cause any deaths. No immediate evacuation.

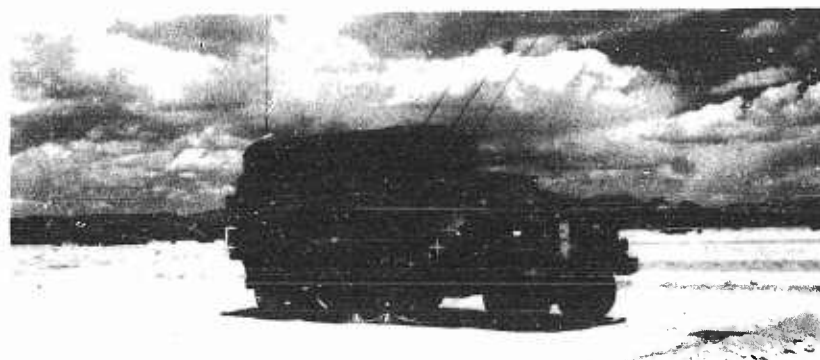
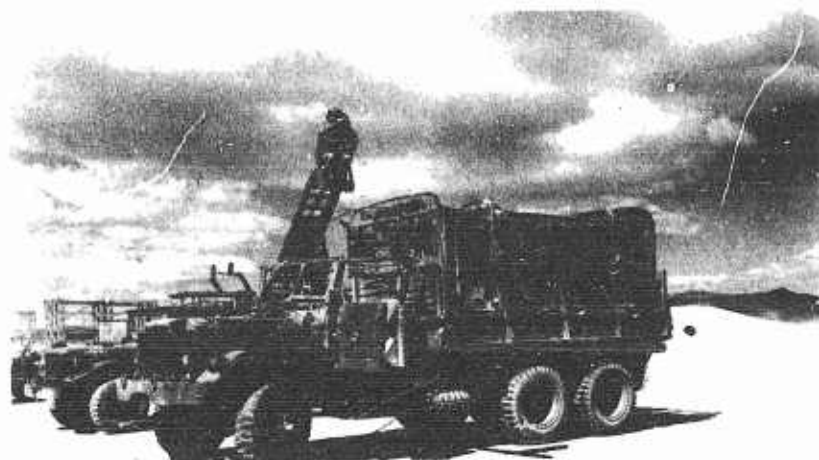
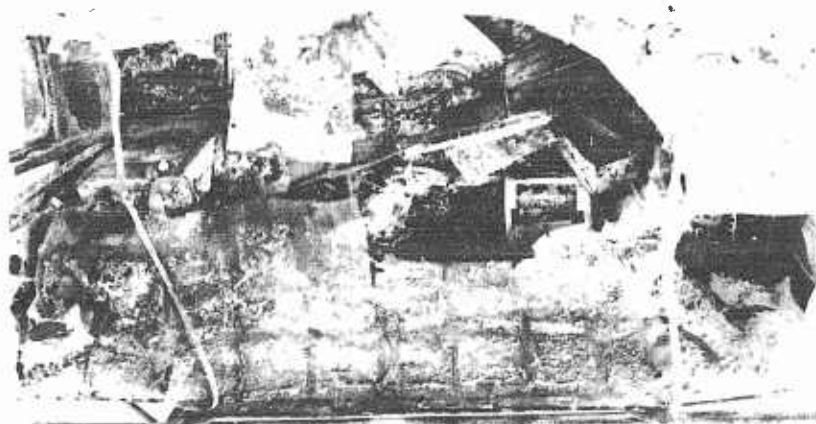
Fig. 3.122 Shot 9, Test Group 81, AN/GRC-26 in Ordnance Corps 2-1/2 Ton Truck. (Top-before, Center-after, Bottom, Interior of AN/GRC-26 Radio Set-after) 2425 ft, 58.5 cal, 10.6 psi, 2280 r at Surface, Interior Gamma Radiation not Known.

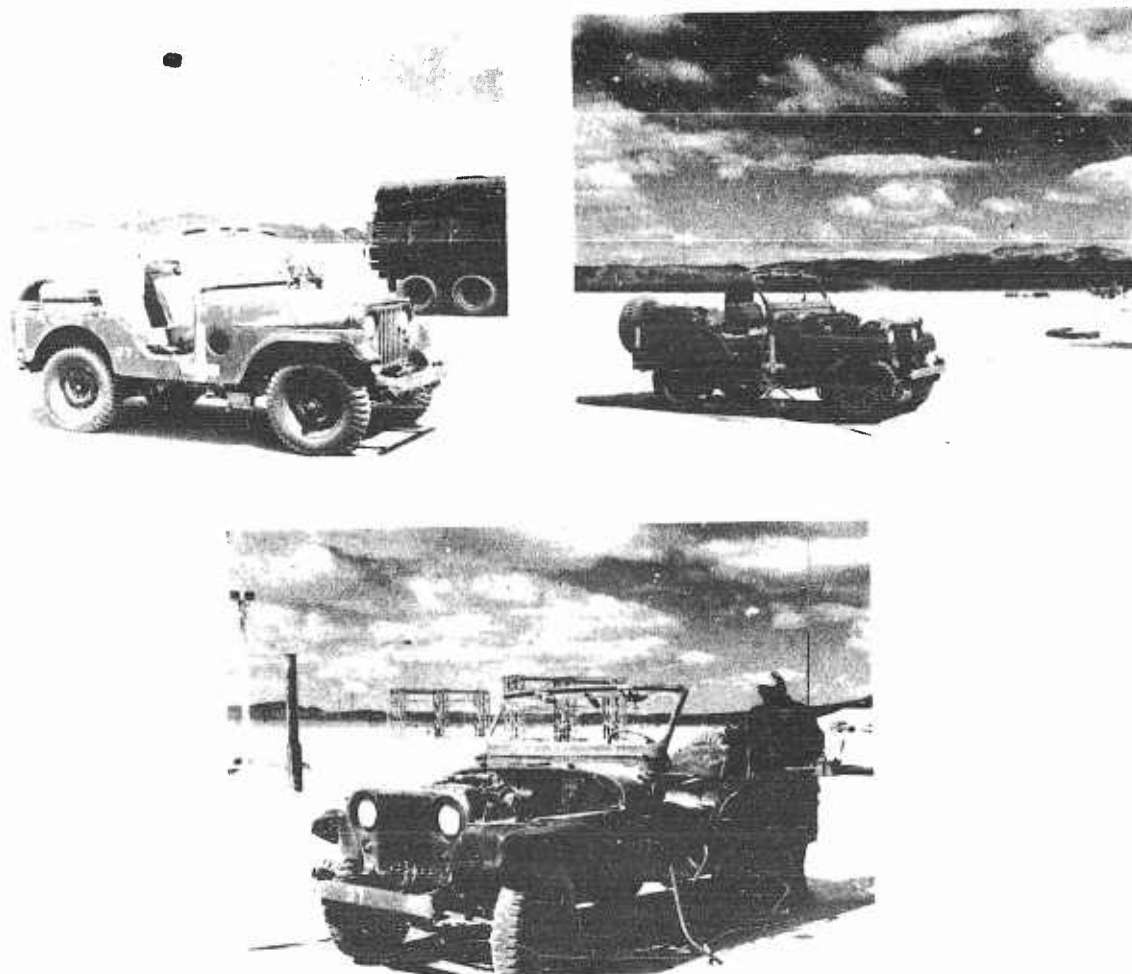
Fig. 3.123 Shot 9, Test Group 81, AN/GRC-9 on Ordnance Corps Jeep.
 (Top left-before, Top right-after, Bottom, Front View-after)
 2425 ft, 58.5 cal, 10.6 psi, 2280 r at Surface.

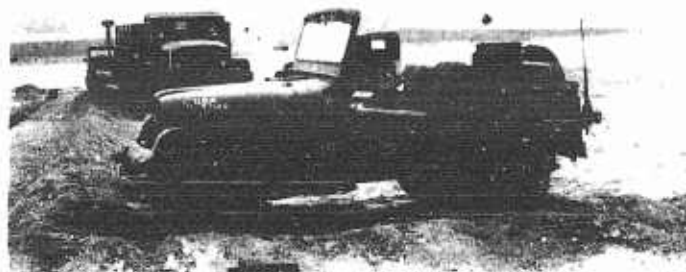
Fig. 3.124 Shot 9, Test Group 82, Radio Set AN/GRC-9 in Ordnance Jeep.
 (Top-before, Bottom-after. Bottom View Taken after Jeep
 had been Driven Under its Own Power from the Test Site.)
 4550 ft, 33.5 cal, 6.9 psi.

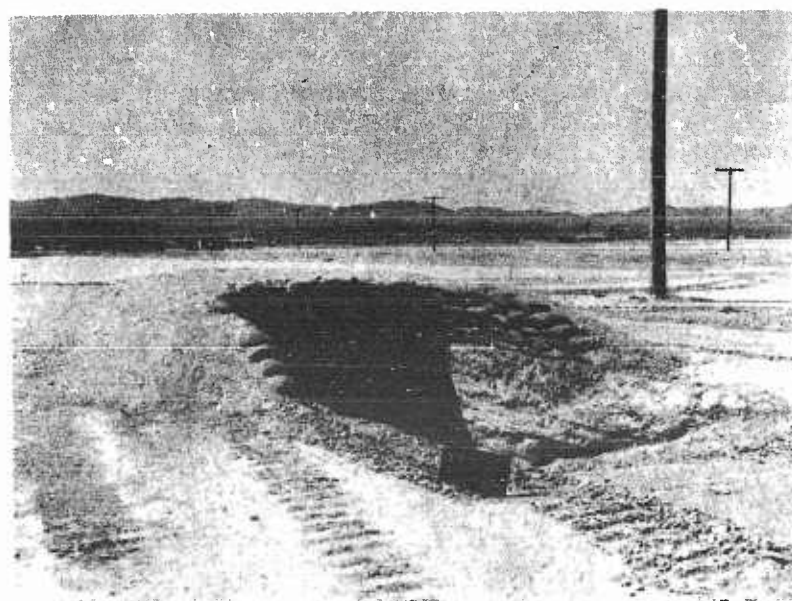
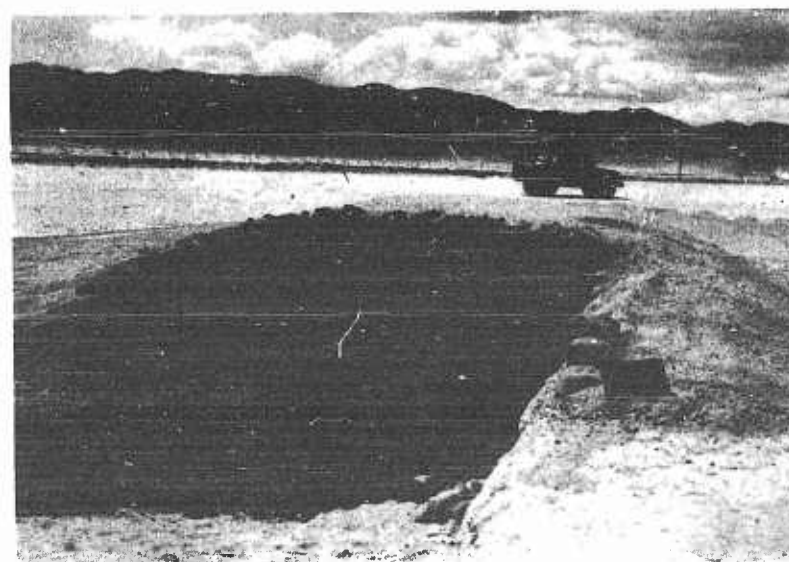
Fig. 3.125 Shot 9, Test Group 59, Shelter S-56 (Revett) with Front
 Away from Ground Zero. (Top-before, Bottom-after)
 2325 ft, 72 cal, 11.6 psi, 2440 r at Surface.

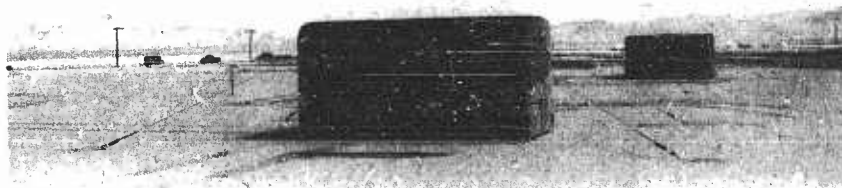
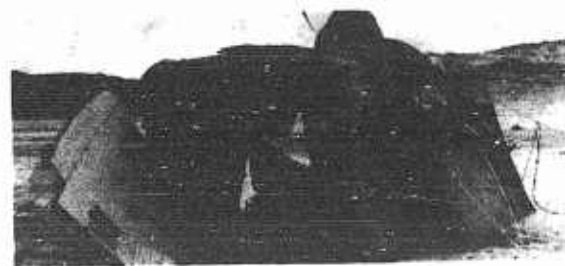
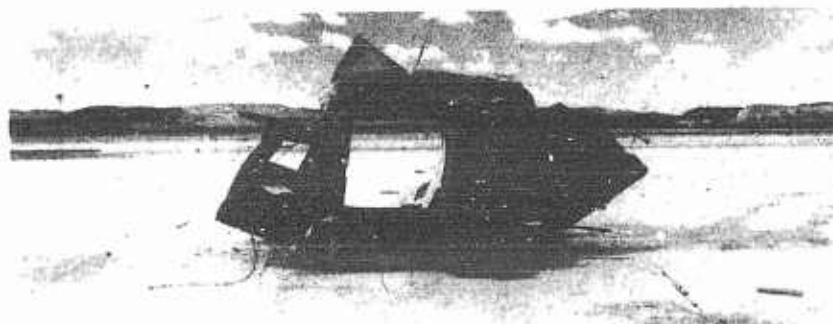
Fig. 3.126 Shot 9, Test Group 60, Shelter S-56 Modified. (Top-before, Second-after, Left, Side-after, Right, Rear-after, Bottom, Front-after) 3050 ft, 57.5 cal, 10.4 psi, 1480 r at Surface.

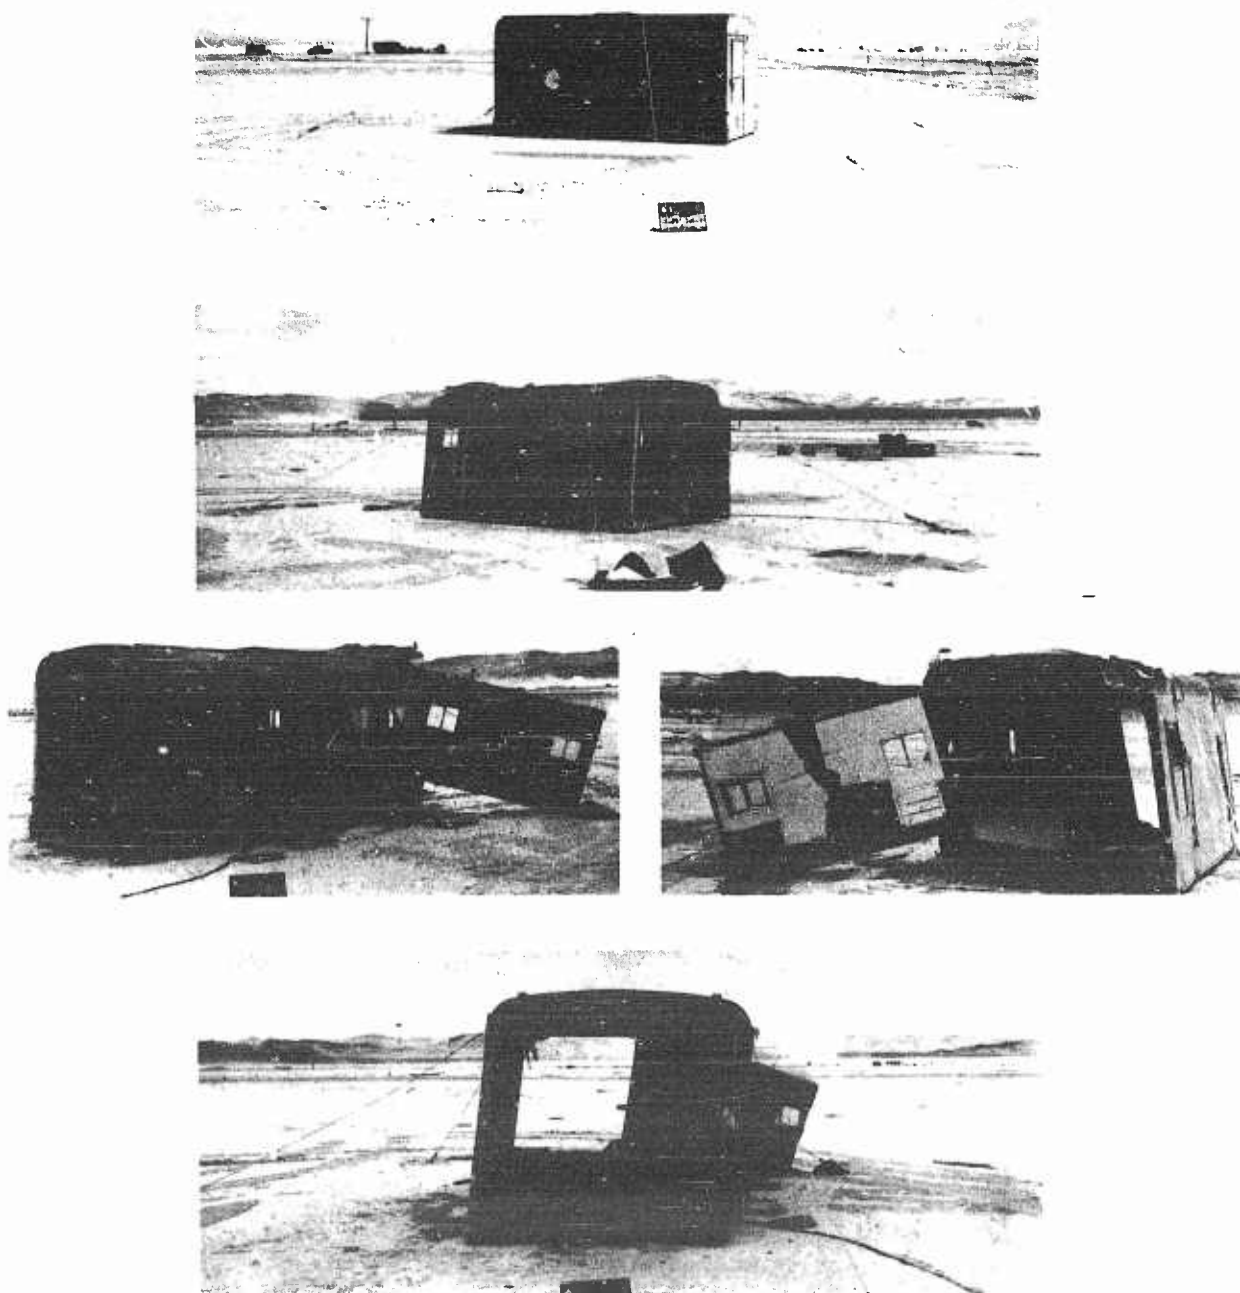
Fig. 3.127 Shot 9, Test Group 61, Shelter S-56 (Standard). (Top-before, Second-after, Left, Side-after, Right, Rear-after, Bottom, Front-after) 3100 ft, 56 cal, 10.4 psi, 1400 r at Surface.

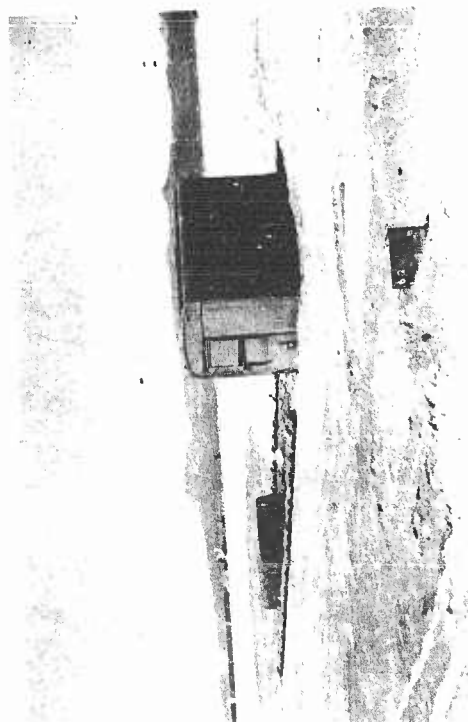
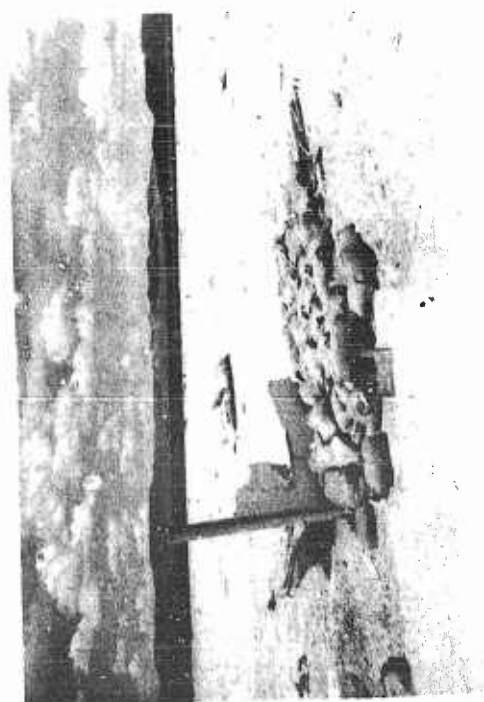
Fig. 3.128 Shot 9, Test Group 62, Shelter S-56.
(Top-before, Left-after, Right-after, Close-up)
3650 ft, 46 cal, 9.0 psi, 720 r at Surface.

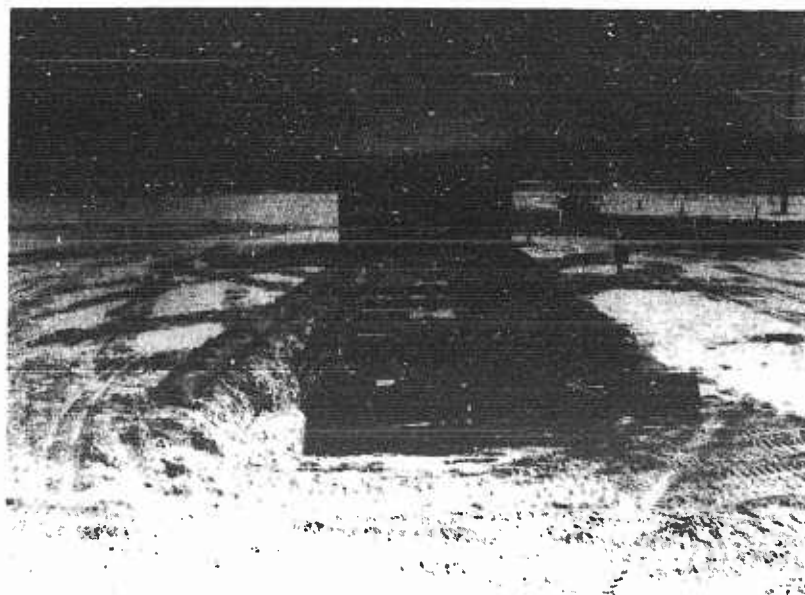
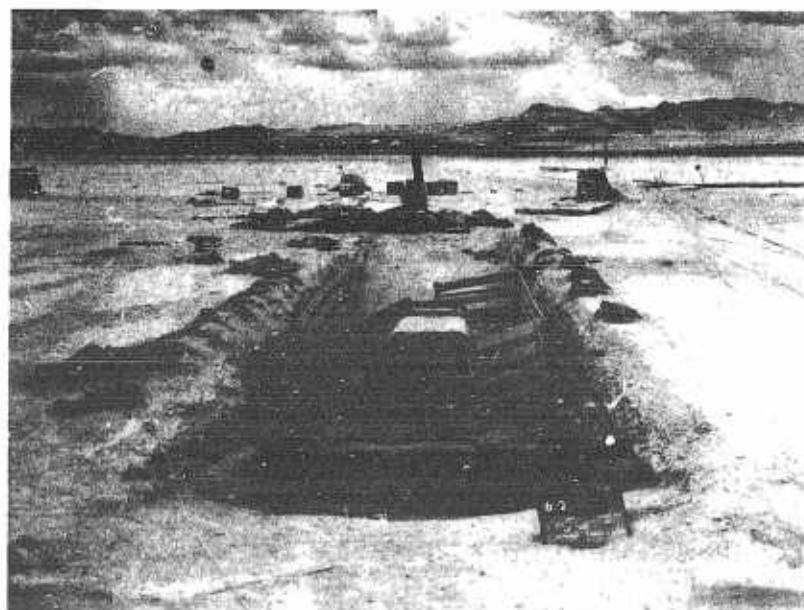
Fig. 3.129 Shot 9, Test Group 62, PE-95 Power Unit in K-52 Trailer in Open Pit Normal to Ground Zero. (Top-before, Bottom-after) 3650 ft, 46 cal, 9.0 psi.

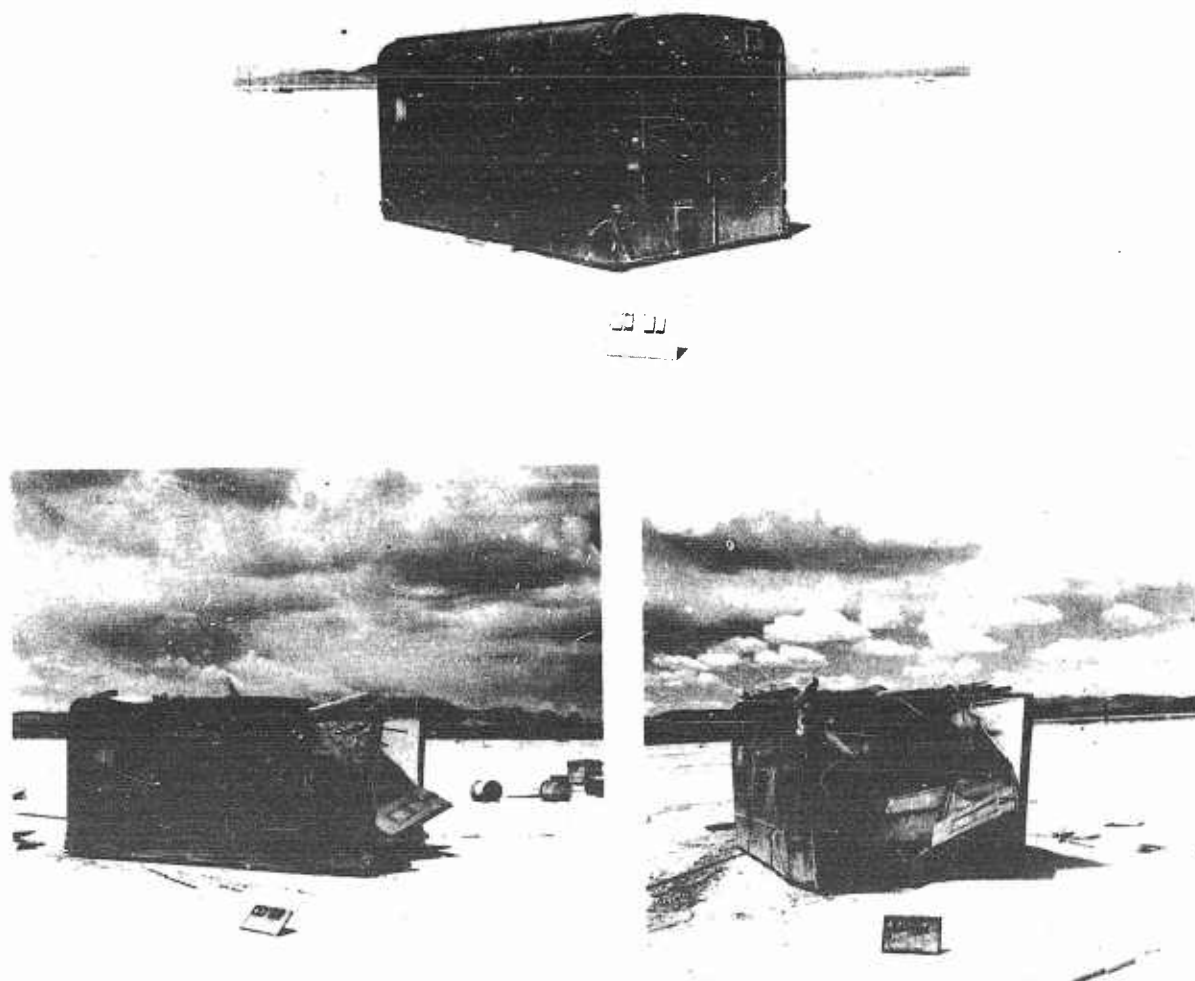
Fig. 3.130 Shot 9, Test Group 63, Shelter S-56. (Top-before, Bottom left-after, Side View, Bottom right-after, Front View)
4650 ft, 32.5 cal, 6.6 psi, 160 r at Surface.

82***	4550	33.5	6.9	200	L	S	Exposed surfaces scorched. Front blown in, top and sides crushed in beyond repair.
63	4650	32.5	6.6	160	N	S	Front blown in, top demolished, sides crushed, beyond repair.
64	5625	24	5.4	80	N	S	Front blown in, top blown in, one side crushed in, one side caved out, blown about 5 ft from original position, beyond repair.

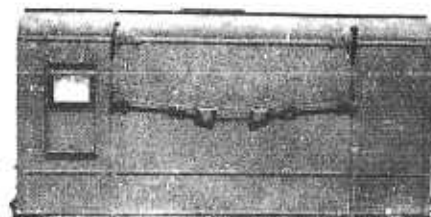
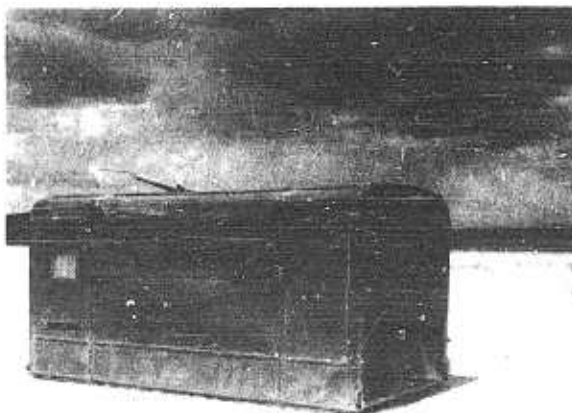
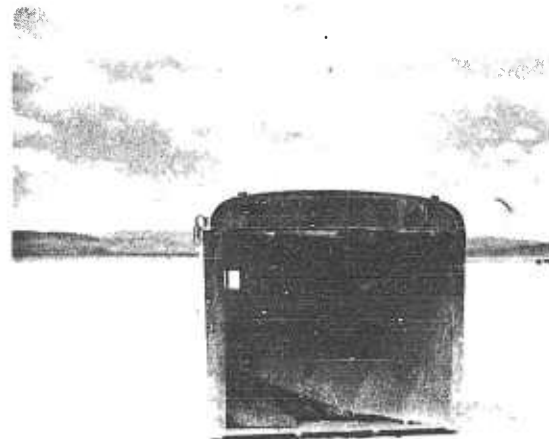
Fig. 3.131 Shot 9, Test Group 64, Shelter S-56. (Top-before, Bottom left-after, Side View, Bottom right-after, Front View)
5625 ft, 24 cal, 5.4 psi, 80 r at Surface.

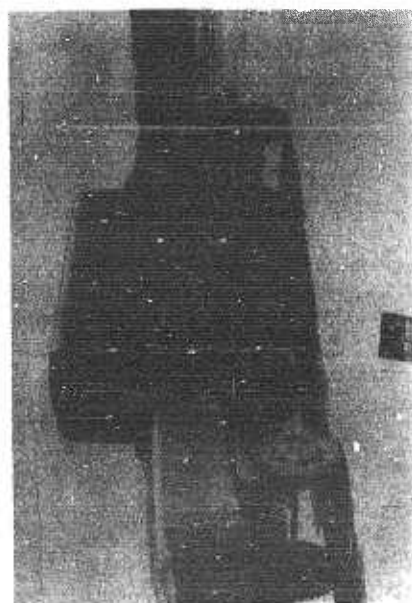
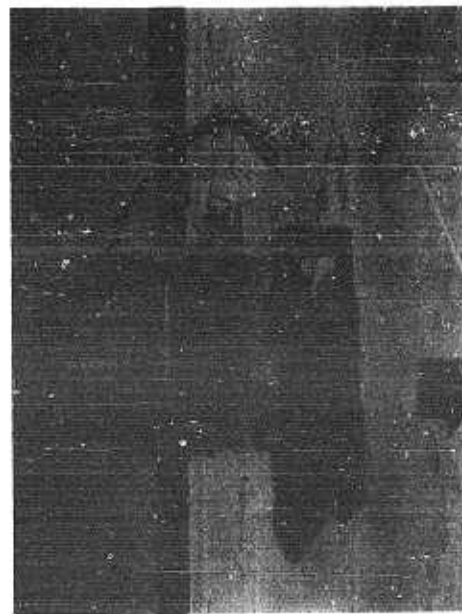
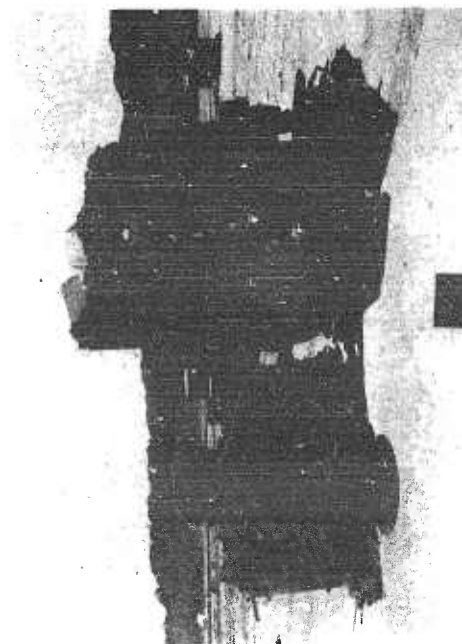
Fig. 3.132 Shot 9, Test Group 80, S-56 Shelter on Ordnance Corps 2-1/2 Ton Truck.
(Top-before, Bottom left-after, Bottom right-after, Front View)
1650 ft, 94.5 cal, 14 psi, 3680 r at Surface.

Test Group No.	Ft from GZ	cal	psi	Surface Gamma	D A M A G E		Remarks
					Thermal	Blast	
80*	1650	94.5	14	3680	L	S	Paint scorched on exposed exterior portions of shelter. Front end of shelter and door blown in, frame twisted, damaged beyond repair.
59**	2325	72	11.6	2440	N	S	The earth revetment provided adequate protection from thermal flux. The front end of this shelter was blown in and torn to pieces. The film badge failed and the interior gamma radiation is not known.
60	3050	57.5	10.4	1480	L	S	Exposed surface slightly scorched. Back of shelter blown out, shelter torn apart and beyond repair. The film badge not found and interior gamma radiation not known.
61	3100	56	10.4	1400	L	S	Exposed surfaces slightly scorched. Front and back blown out, sides and top crushed, beyond repair. Film badge not found, interior gamma radiation not known.
62	3650	46	9	720	L	S	Exposed surfaces lightly scorched. Shelter completely demolished.
